INDOOR AIR QUALITY ASSESSMENT

**District Court of Worcester County
(Worcester District Court)
50 Harvard Street
Worcester, Massachusetts**

Prepared by:
Massachusetts Department of Public Health
Center for Environmental Health
June 2005

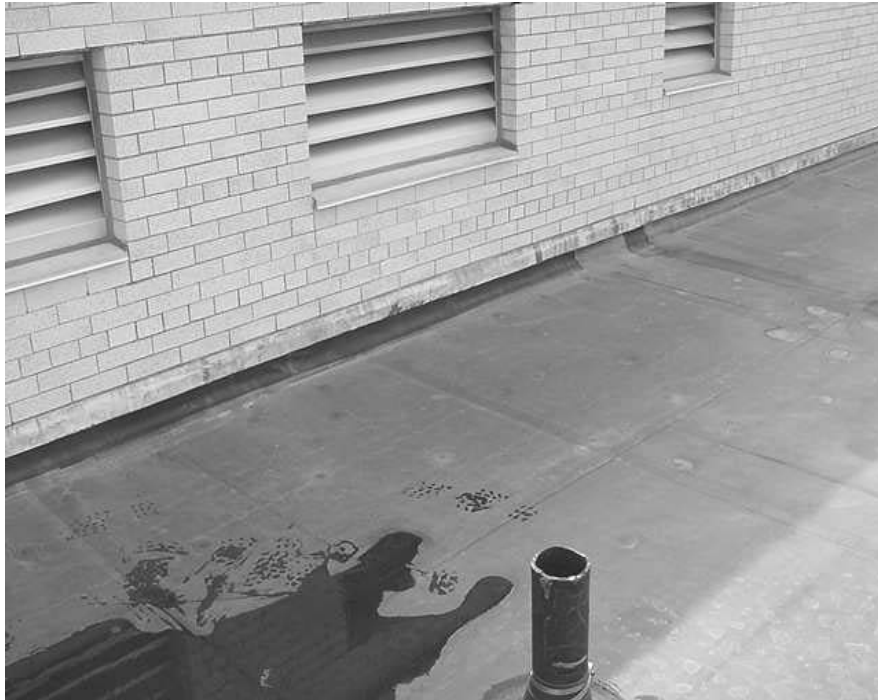
Picture 1

Ventilation is provided by various air-handling units (AHUs) with fresh air intakes located on the roof (Picture 1) and at ground level (Picture 2) of the building. MDPH staff received numerous complaints concerning heat control in this building. The lack of heat control appears to be related to the design of the ventilation systems. Fresh air is distributed through the building by diffusers (Picture 3) that, in the experience of MDPH staff, are used in buildings with a large indoor space requiring heat (e.g., department stores or industrial settings). Courtrooms at the WDC are outfitted with four of these air diffusers per ceiling (Picture 4). Some offices converted from use as jury rooms have two of these vents.

A sewer vent pipe was observed in close proximity to fresh air intakes on the roof. Under certain wind conditions, sewer gas from this vent may be entrained by the HVAC system.

Rooftop Fresh Air Intake Vents (Note Sewer Vent Pipe on Foreground)

8. Consider posting signs instructing vehicles to park face in towards the building and to shut engines off after five minutes as required by Massachusetts General Laws 90:16A.
9. Extend the height of sewer vent pipes on the roof a minimum of 2 feet above fresh air intakes for AHUs.

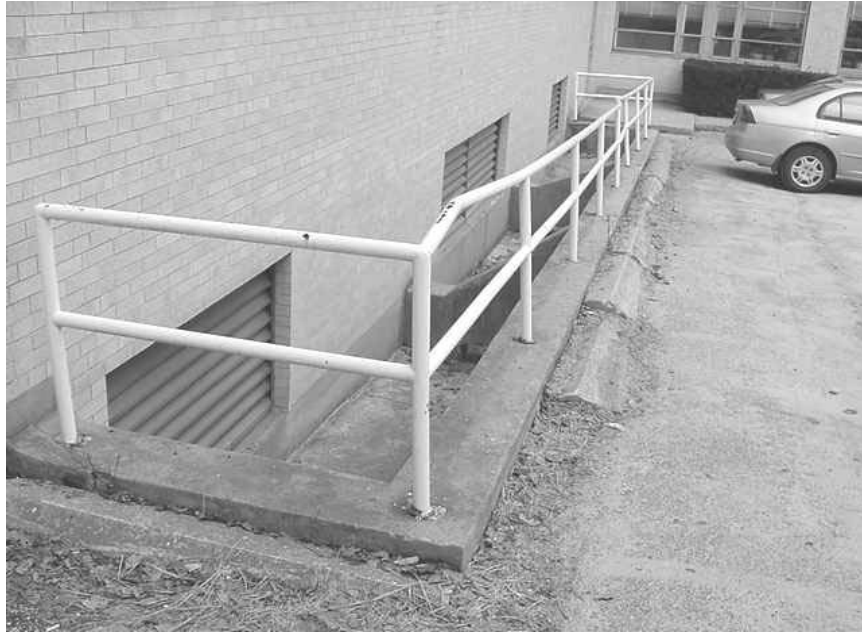
Picture 2

Indoor air quality can be adversely impacted by the presence of respiratory irritants, such as products of combustion or sewer gas. Occupants reported periodic complaints of vehicle exhaust entrainment from vehicles parked along the courtrooms serviced by the ground level fresh air intakes shown in Picture 2. During certain wind and weather conditions, vehicle exhaust can potentially be drawn, or entrained, through the univent fresh air intakes. This in turn may provide opportunities for exposure to compounds such as carbon monoxide. M.G.L. chapter 90 section 16A prohibits the unnecessary operation of the engine of a motor vehicle for a foreseeable time in excess of five minutes (M.G.L., 1986).

Ground Level Fresh Air Intake Vents (Note Position of Car with Tail Pipe Pointed Towards Intake)

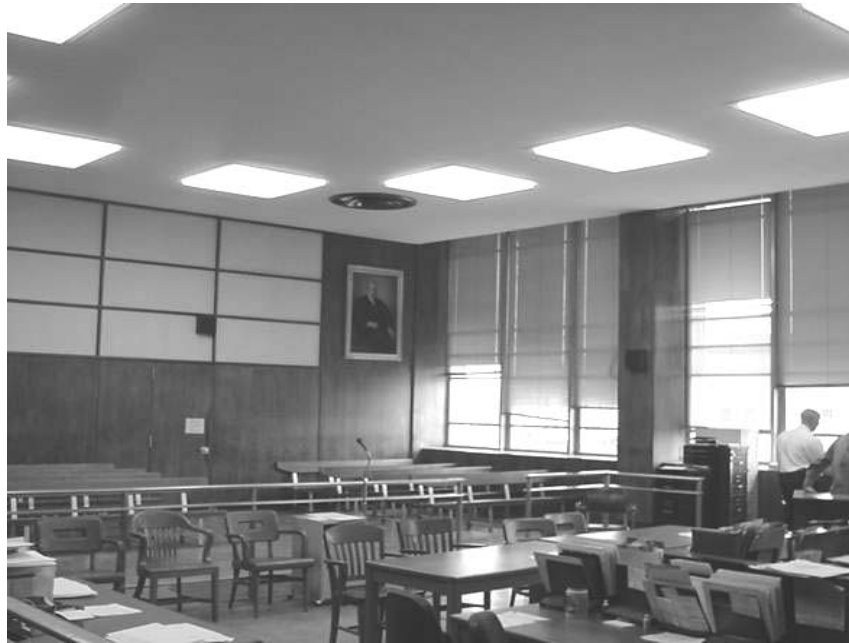
Picture 4

Court Room Ceiling with Air Diffusers (One of Four in Room)

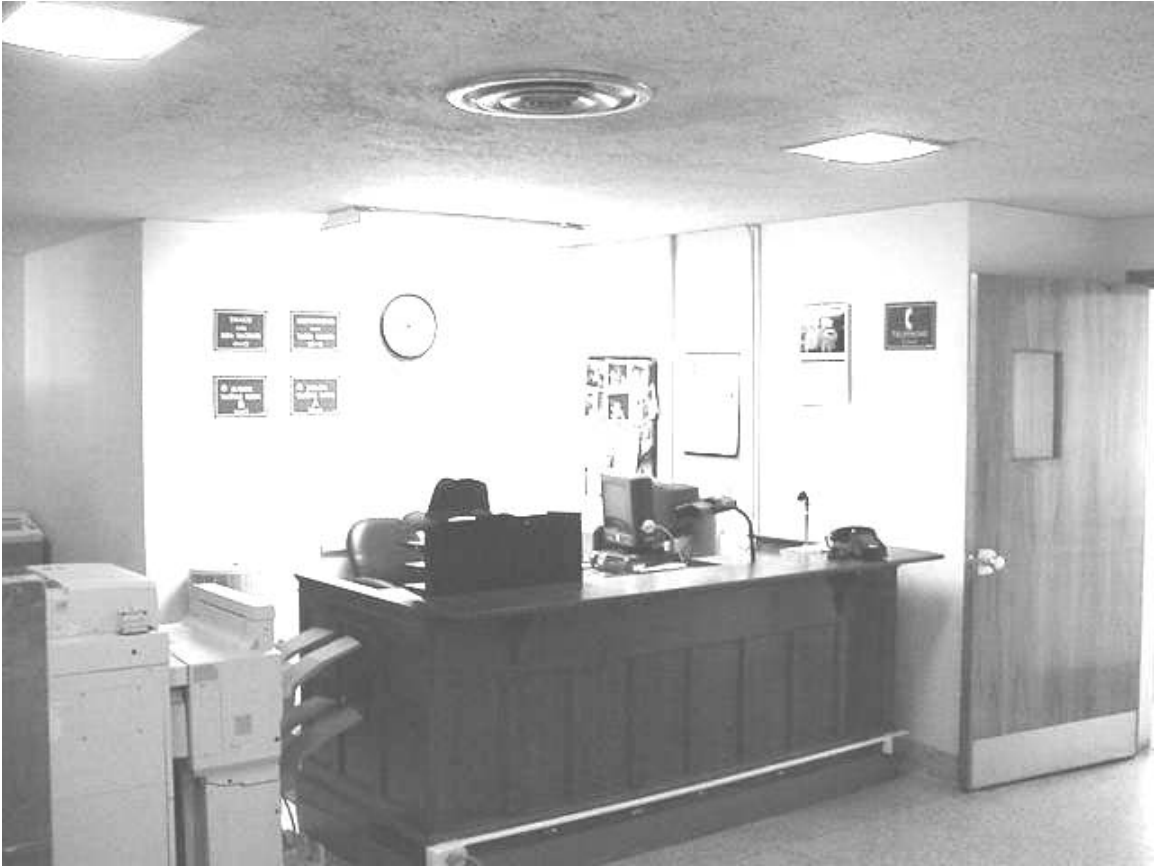
Picture 5

The jury pool court officer's desk is located in a hallway outside two jury rooms (Picture 5). The sole source of fresh air and exhaust ventilation in this area is a ceiling mounted fresh air diffuser/exhaust vent unit described previous. A number of pieces of office equipment that produce waste heat (e.g. photocopier, computer monitor) are also located in the area. Due to the design of the ventilation system, exhaust ventilation is limited in this area.

Jury Pool Court Officer Desk

4. Vent the portable air conditioner in the DA's Office outdoors.
 5. Examine the feasibility of improving exhaust ventilation for the jury pool area.
 6. Consider sealing the fresh air supply for the jury pool court officer's desk. As an interim measure, place the high efficiency particle arrestance (HEPA) filter located behind the desk next to the photocopier and office door to intercept pollutants. Consider moving the photocopier to an area of larger volume that is equipped with exhaust ventilation.

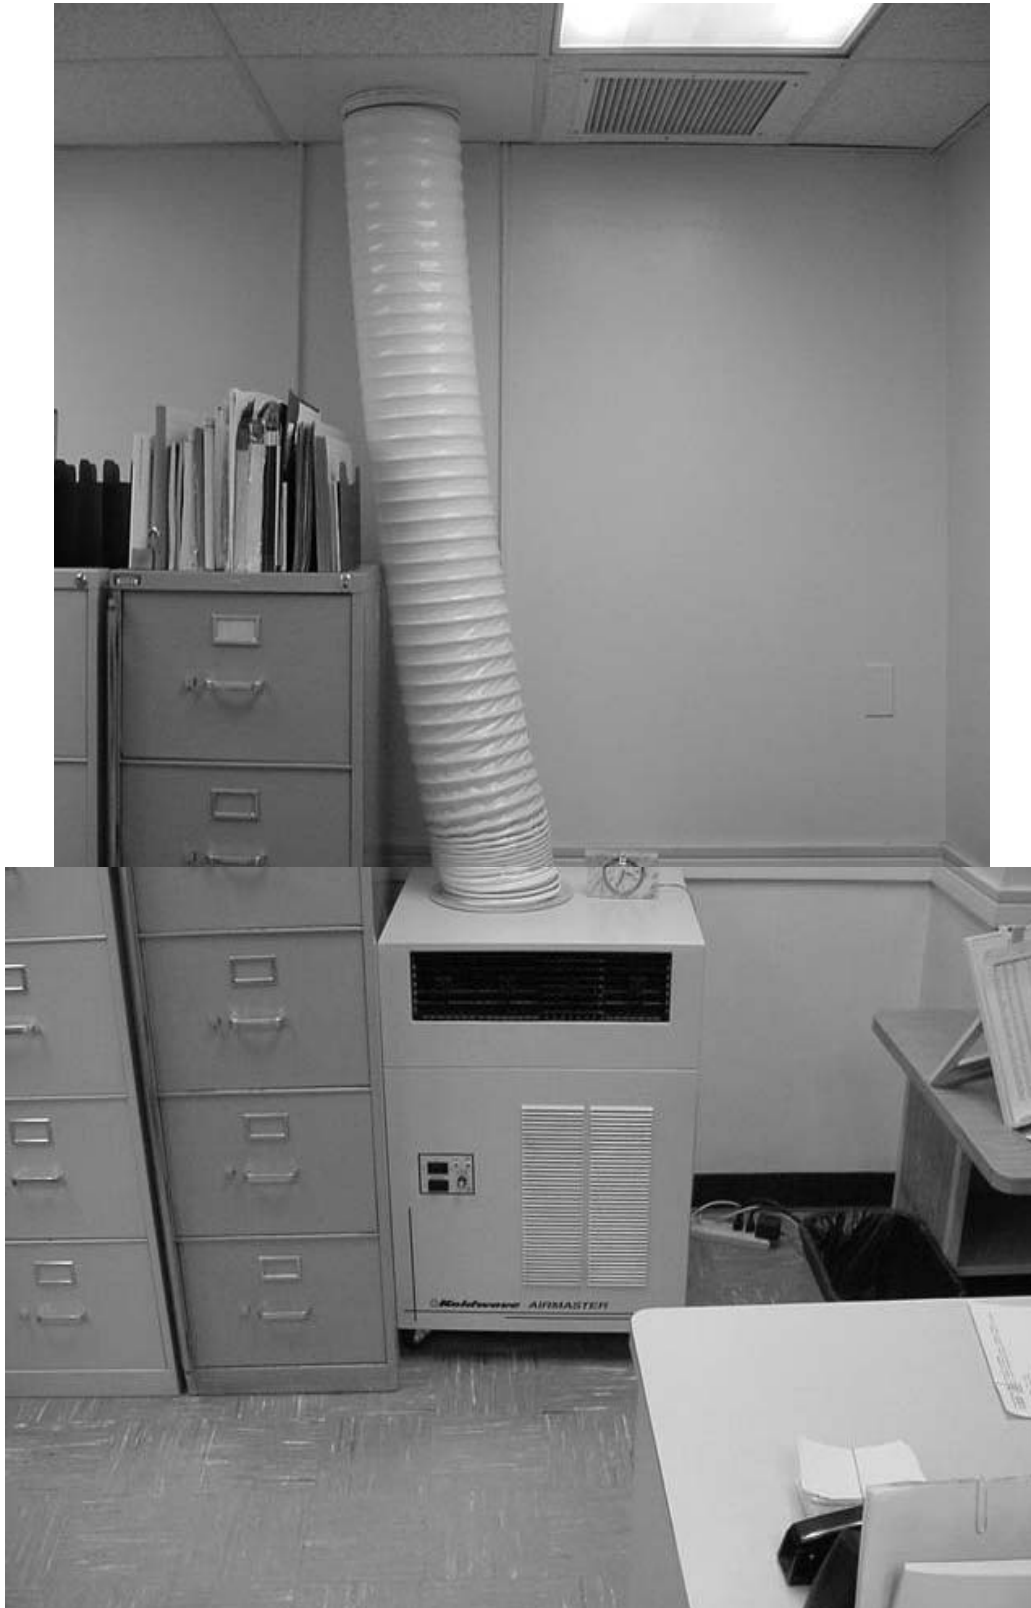
Picture 6

Another area with heat concerns is an internal office within the DA's Office. In an effort to control temperature during summer months, a portable air conditioner was installed inside this office (Picture 6). This air conditioner is *designed* for use in a building that has a ceiling plenum¹ return air system. Based on the unit design, waste heat generated by the portable air conditioner would be drawn into the ventilation system. However, the HVAC system at the WDC is *ducted* for both supply and return. The WDC *does not* use the ceiling plenum for return ventilation. In this room, heated air is vented into the ceiling, which pressurizes the area above the ceiling to force hot air back into the room. This system should be ducted directly to a vent in the exterior wall.

Portable Air Condition in DA's Office, Note Flexible Hose into Ceiling (Composite)

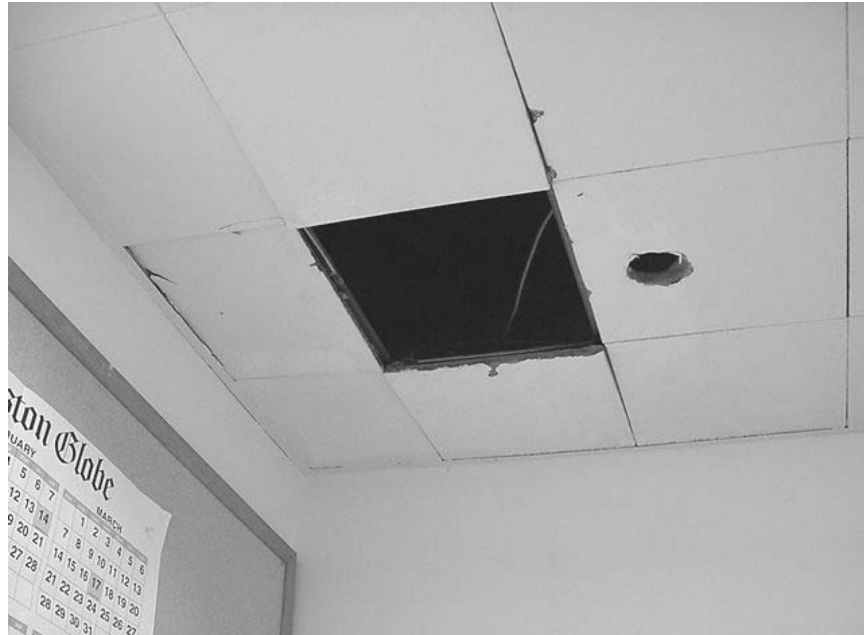
Picture 7

The WDC has an interlocking ceiling tile system (Picture 7). Several hallways and offices have ceiling tiles that appear to be water-damaged by old roof leaks. Replacement of these ceiling tiles is difficult due to their design. The American Conference of Governmental Industrial Hygienists (ACGIH) and the United States Environmental Protection Agency (US EPA) recommend that porous materials be dried with fans and heating within 24 to 48 hours of becoming wet (ACGIH, 1989; US EPA, 2001). If porous materials are not dried within this time frame, mold growth may occur. Water-damaged porous materials cannot be adequately cleaned to remove mold growth. The application of a mildewcide to moldy porous materials is not recommended. Fungal microbial growth begins once water soaks porous materials.

Interlocking Ceiling Tiles
